EGR VALVE CLEAN (Ever 70,000 miles or when you see clouds of black exhaust smoke when accelerating hard)

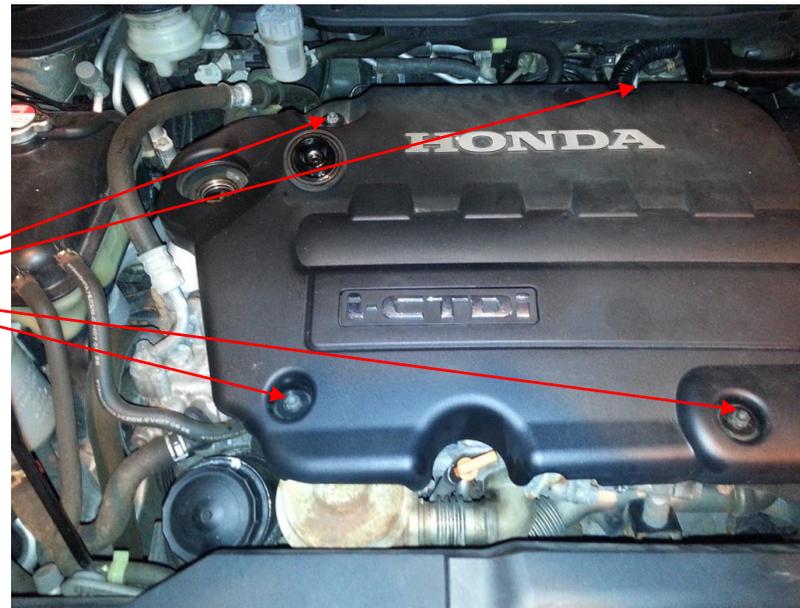
STEP 1

Remove the four nuts and washers holding the engine cover in place and then remove the engine cover.

Be careful not to lose the washers.

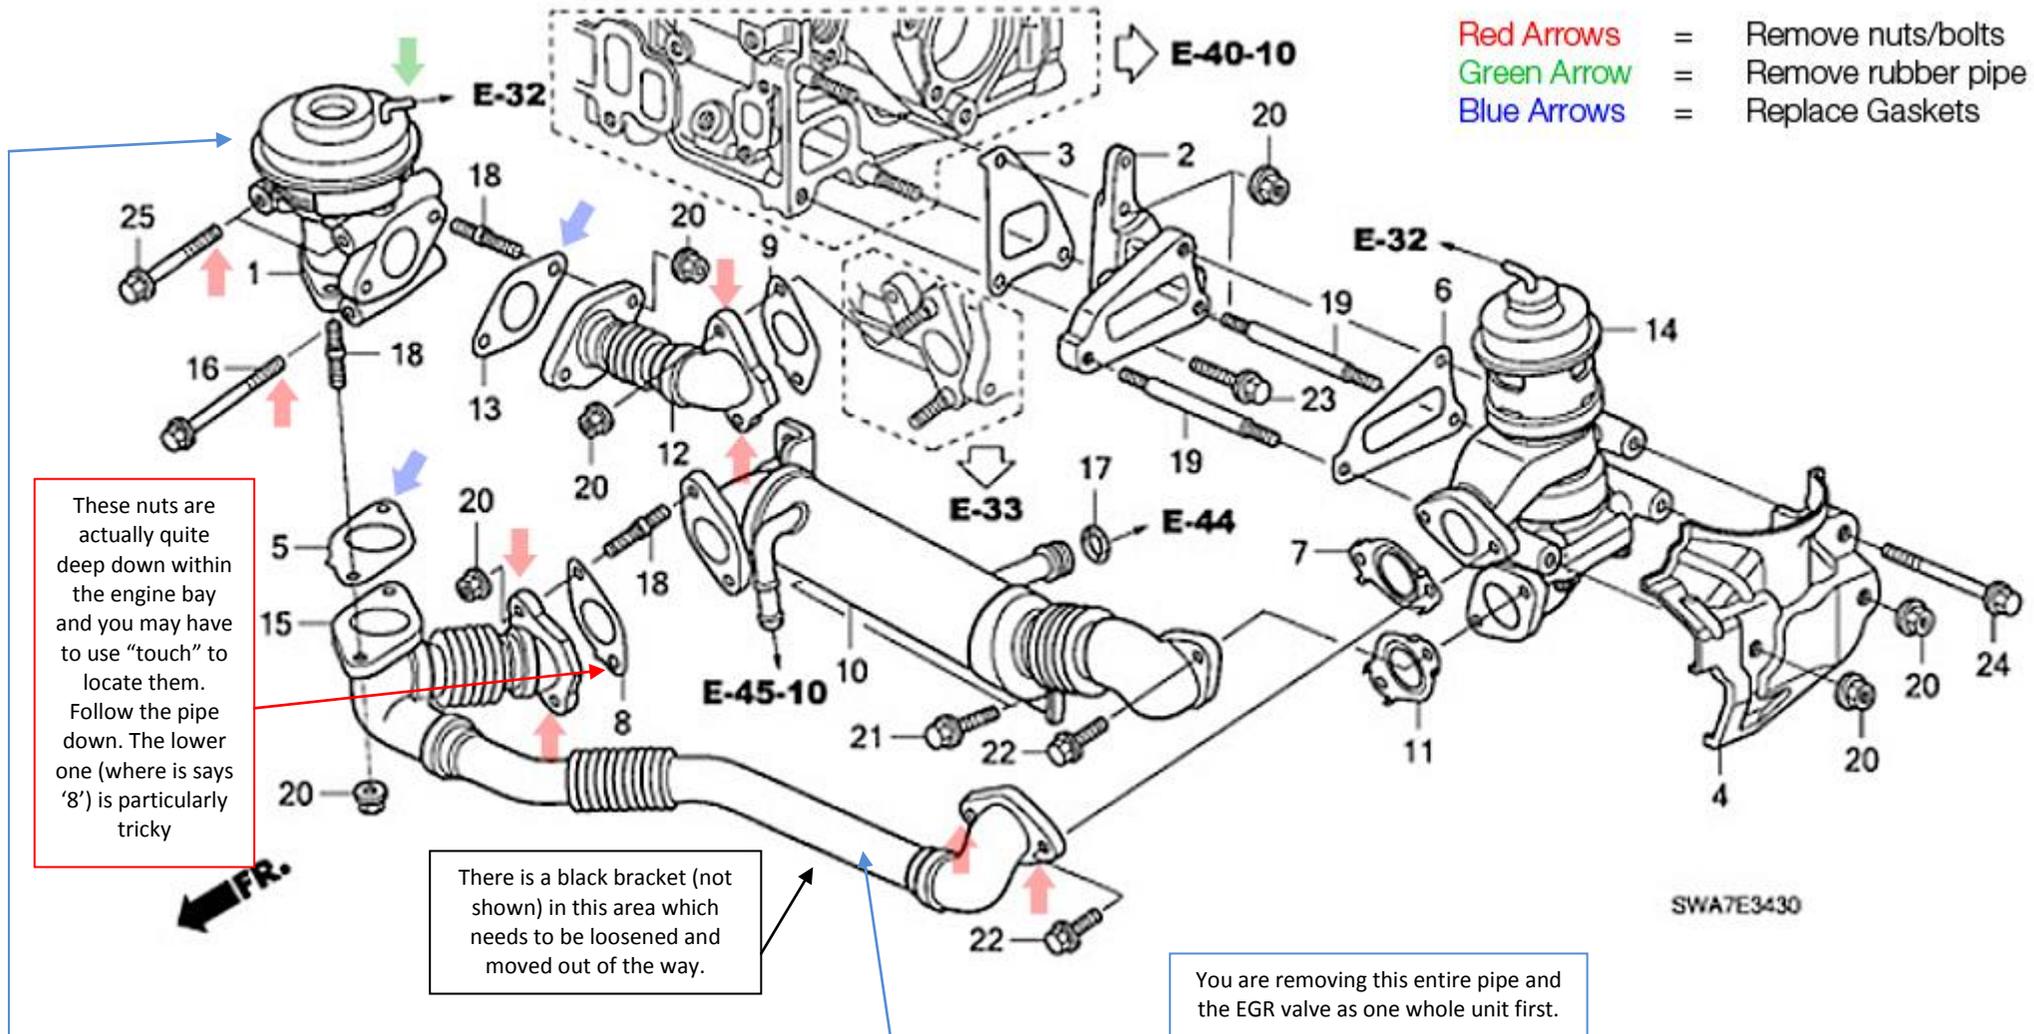
STEP 2

Instead of just removing the EGR Valve where access to some of nuts is almost impossible, it is easier to simply remove the EGR Valve and Cooling Pipe as one unit and then remove the EGR valve once it is all out of the engine bay. See the legend below for what the arrows mean.

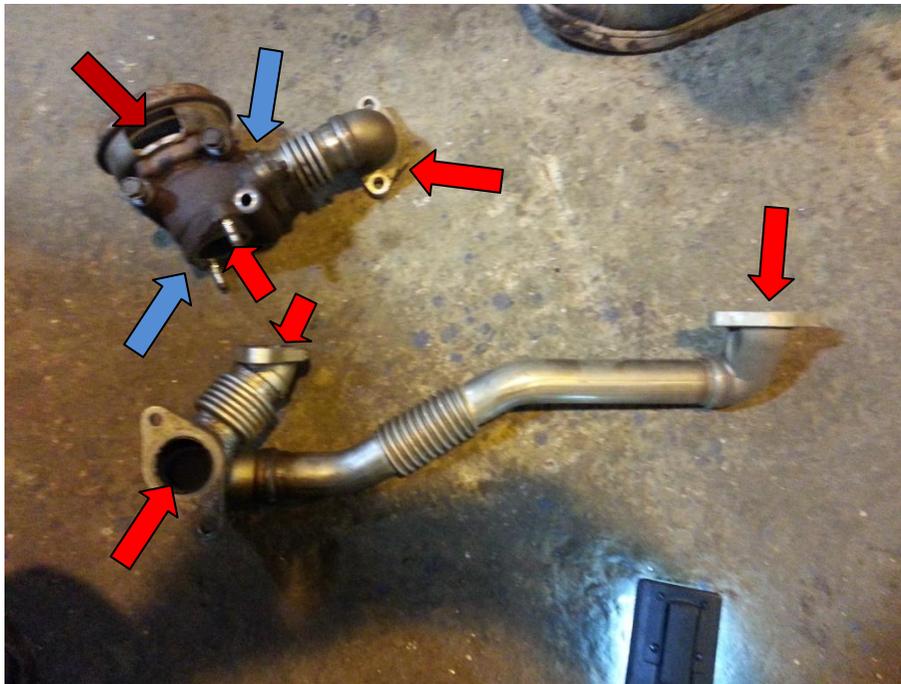
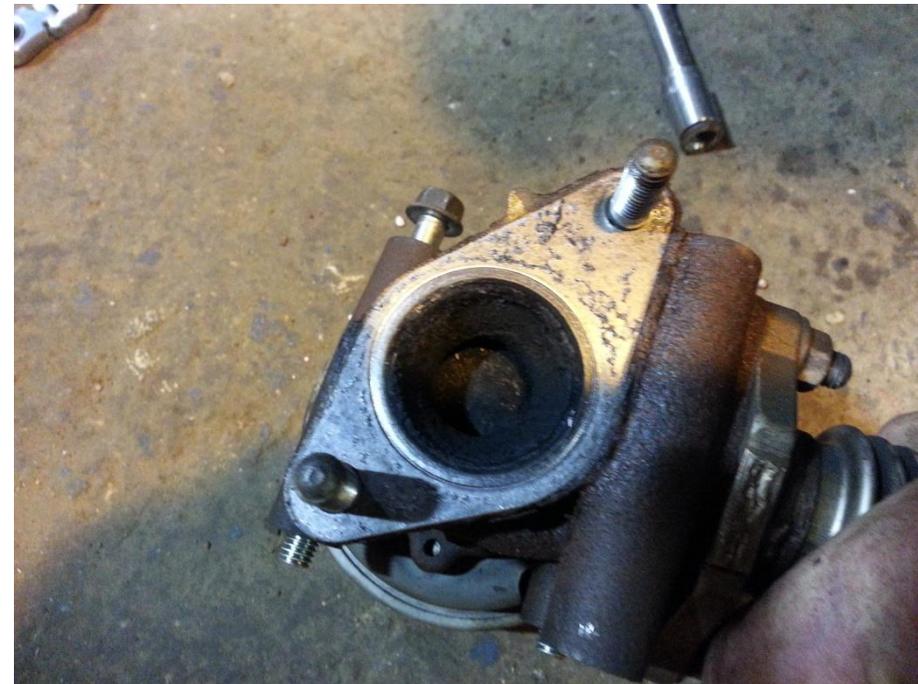
STEP 3

Once you have removed the EGR Valve and the Cooling Pipe you can now separate the EGR valve from the pipe in order to gain better access to the valve and also the small extension pipe can be separated (this will allow access to replacing one of the two gaskets). Using brake cleaner or a suitable high strength cleaner which will not leave any residue and will evaporate quickly, spray copious amounts into all the areas marked with red arrows below. You can see that mine wasn't too bad (see photo below on the right) but it was quite blocked up inside the actual housing (dark red arrow)

Leave to soak for about 5 minutes then spray more and start digging away carefully at the carbon with a flat headed screw driver and also using cloths. Give the cooling pipe a good soak also and try to clean out as much from inside there also but the main focus is the valve. Don't forget to clean inside the actual valve housing also (see the dark red arrow)

Remember to replace the gaskets (marked with blue arrows) and don't forget that they are not identical gaskets. You could go nuts and replace all the gaskets but I found that only the two on the actual EGR valve itself needed to be replaced. Once cleaned put it all back together and start her up. If you hear a crack when you first start up the engine don't worry it will just be a little bit of carbon entering the engine and it will burn off and the noise shouldn't happen again or after a few starts.
